Study of Failure of the Steam Tubes of Boiler Furnaces in Najebia Power Plant

Prof. Dr. Saleh E. Najim Dr. Haider M. Mohammed
College of Engineering – Basrah University

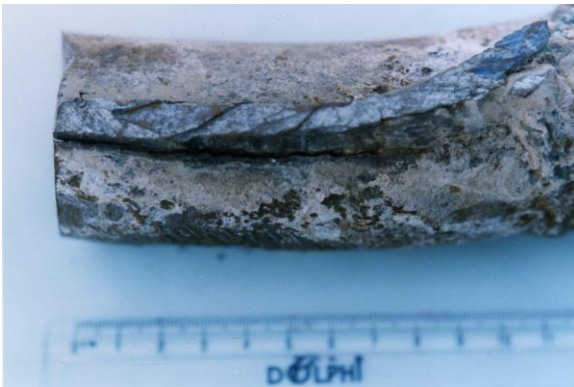
which had leaked, a heavy accumulation of black deposits and brown oxide film were found on the inner surfaces (Fig.1). Some pitting corrosion had occurred in the inner surface (Fig.2). Tubes failed by cracking (Fig.3), and the reduction in the wall thickness is also observed (Fig.4).

Fig. 3 Cracking in the tube

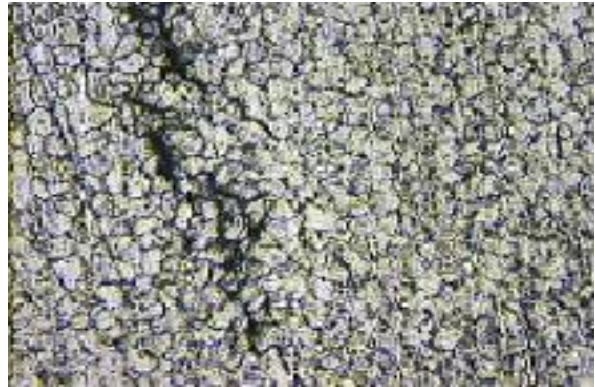
3. Microscopic Test Results: The microstructure of the new tube is given in Figure 5, which formed from two phases structure of pearlite and ferrite. Figure 6 shows the microstructure of the tube that failed by rupture, there was a phase transformation from pearlite to ferrite; then, the metal of the tube became weak. Figure 7 shows the microstructure of tube with cracking. This change in microstructure resulted due to overheating of the wall tubes [7].

Fig. 7 Microstructure shows cracking (X200)

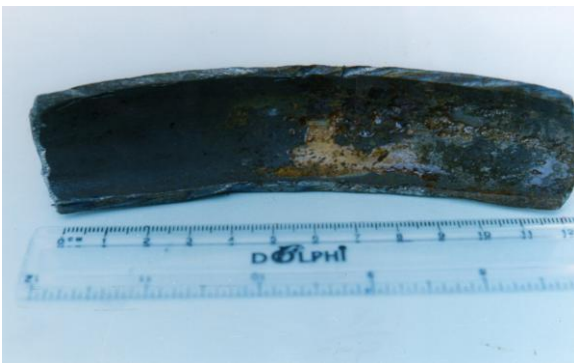
Fig. 4 Wall Thinning (Erosion)
